Walkability Audit

19th January 2016

**St. Michael's College,
Ailesbury Road,
Dublin 4.**

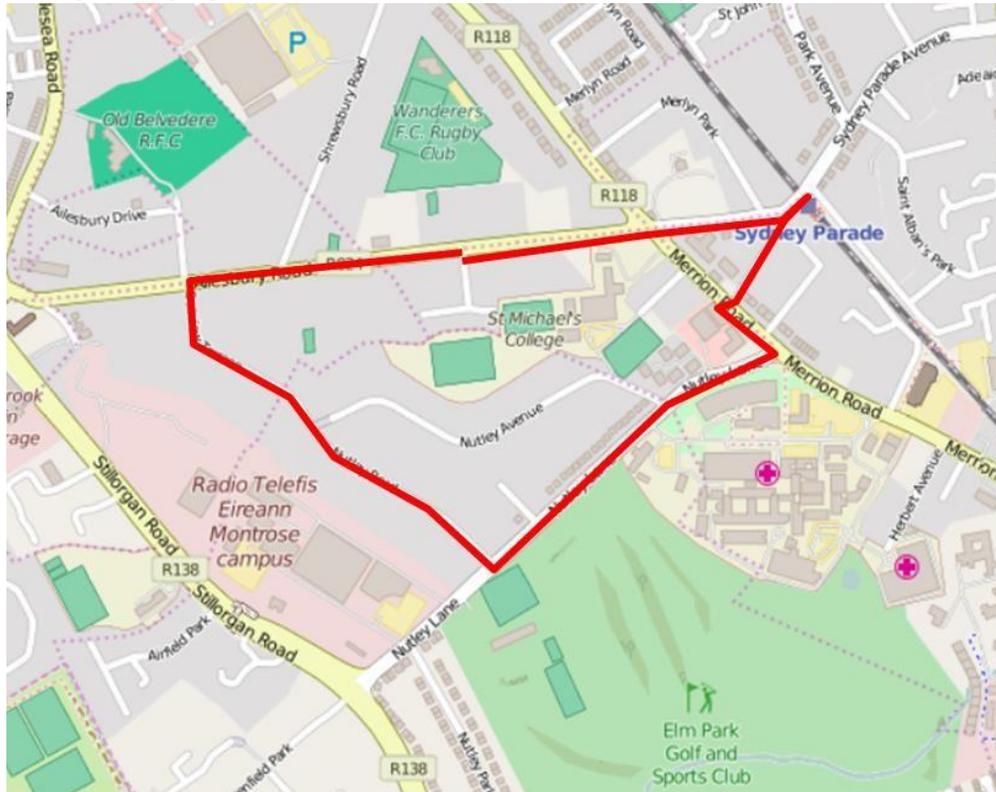
Not to scale

The area surrounding St. Michael's College was audited for pedestrian safety. The audit began at the vehicular entrance on the Ailesbury Road (R824) and continued in an easterly direction towards the Merrion Road junction (R118). Crossing this junction, the audit continued on to Sydney Parade Dart Station. Upon reaching the station, the audit team travelled southwest along Sydney Parade Avenue to Nutley Lane and

completed by turning northwest onto Nutley Road. The audit covered a distance of over 2 km. The location of the school and the audit routes taken by the pupils are illustrated on the map below.

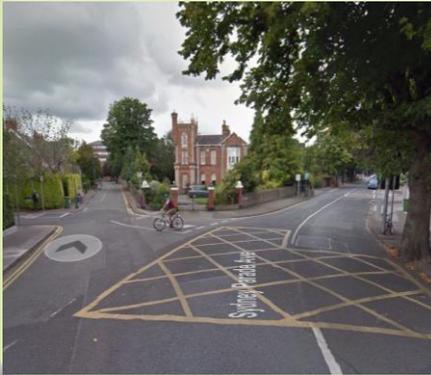
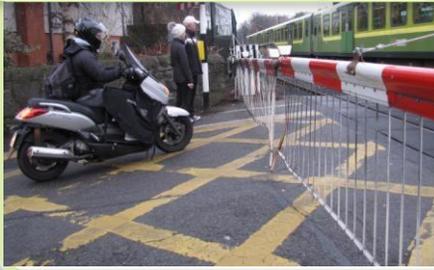
3. The junction of Ailesbury Road and Sydney Parade Avenue is a hazard for pedestrians. A tight corner and the location of road markings combine to form a blind spot where the visibility of crossing pedestrians is greatly reduced.

Crossing the junction of Ailesbury Road and Sydney Parade Avenue is a hazard for pedestrians. The tight corner and location of the road markings creates a blind spot for pedestrians crossing. The visibility at this corner is poor.

Recommendation: A pedestrian zebra crossing (RPC 001) could be useful at this junction on Sydney parade Avenue. For safety, a guard rail may also be necessary on the 'blind' corner.

A pedestrian zebra crossing would be useful at the junction of Ailesbury Road and Sydney Parade Avenue. A guard rail may also be necessary on the corner.

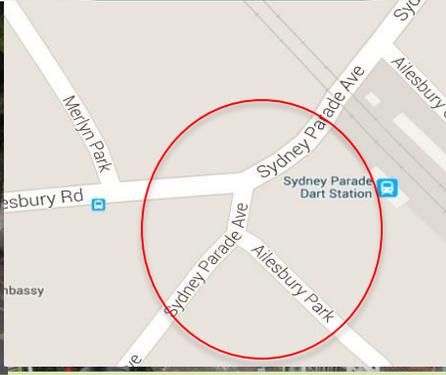
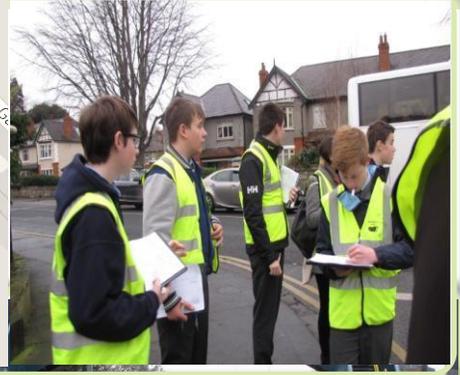
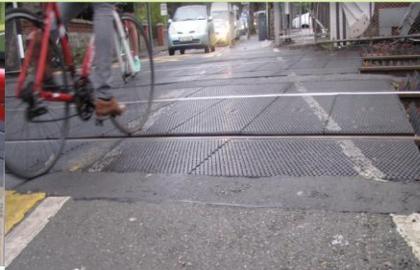
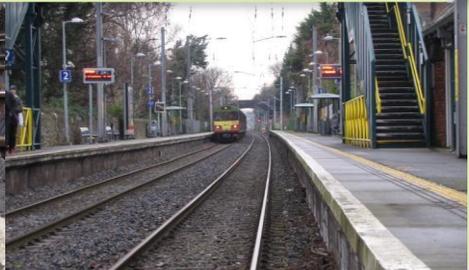
4. The Dart line impedes the progress of pedestrians and creates a hazard. The safety barrier can be down for up to four minutes during commuter times. When this barrier lifts, pedestrians must negotiate the crossing with heavy traffic. This is particularly an issue at peak times.

The Dart line impedes the progress of pedestrians and creates a hazard. The safety barrier can be down for up to four minutes during commuter times. When this barrier lifts, pedestrians must negotiate the crossing with heavy traffic. This is particularly an issue at peak times.

Recommendation: Pedestrian permeability and safety should be evaluated. Access to the existing pedestrian footbridge over the railway line at Sydney Parade Dart Station for the use of pedestrians at peak times could be considered.

of pedestrians at peak times could be considered.

Pedestrian permeability and safety should be examined. Access to the existing pedestrian footbridge over the railway line at Sydney Parade Dart Station for the use

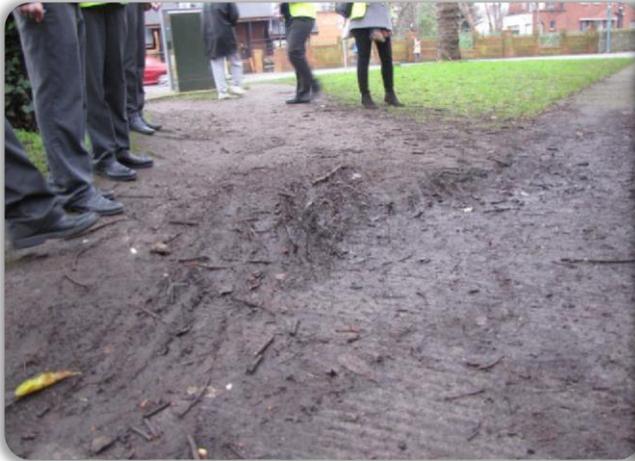
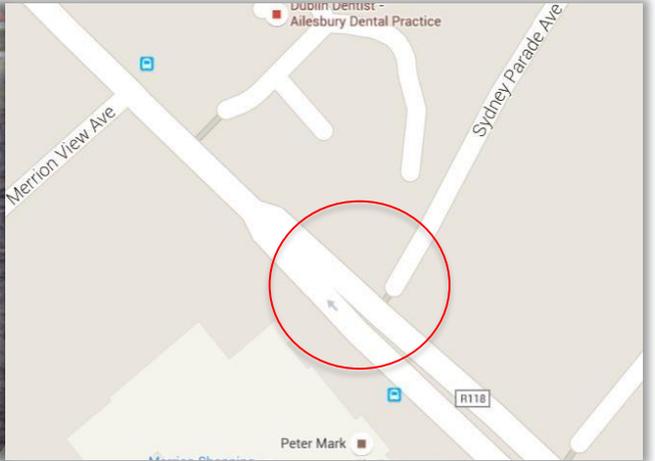
5. The formal pedestrian pathway from Sydney Parade Avenue to the Merrion Road is covered with muck and debris. Pedestrians have forged an informal, more direct, pathway leading to the pedestrian lights.

Pedestrian pathway from Sydney Parade Avenue to the Merrion Road is in a bad state to repair. The formal pathway is buried under muck and debris. Pedestrians have forged an informal direct pathway leading to the pedestrian lights.

Recommendation: This informal pathway could be paved and the existing pathway should be cleaned and upgraded.

potholes. These are a hazard for pedestrians. This informal pathway could be paved, the existing pathway needs to be upgraded.

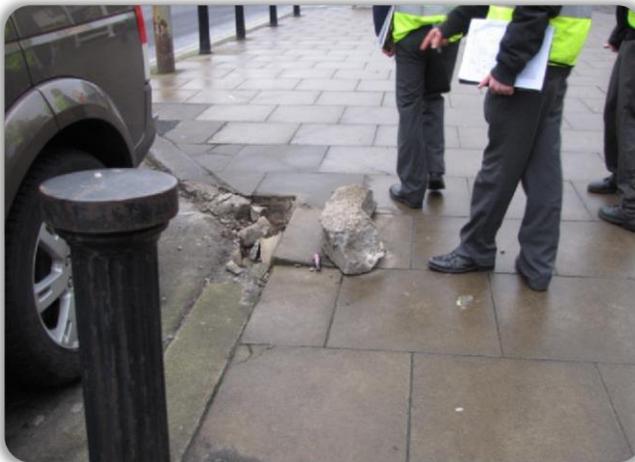
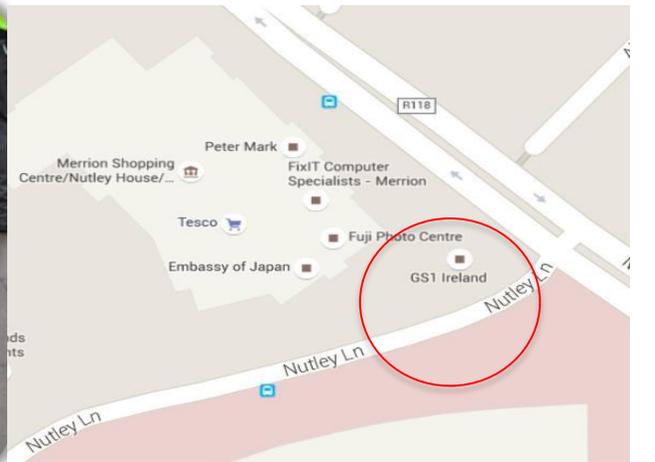
6. The footpath around the loading bay on Nutley Lane has many potholes. These loose blocks and unstable pieces of paving are a hazard for pedestrians.

The footpath around the loading bay on Nutley Lane has many

Recommendation: The footpath needs to be repaired beside the loading bay of the Merrion Shopping Centre on Nutley lane.

This footpath needs to be repaired beside the loading bay on Nutley lane.
